# Successful solution to the challenge of low RPM bearing monitoring

BY: Tim Sundström, SPM Instrument AB

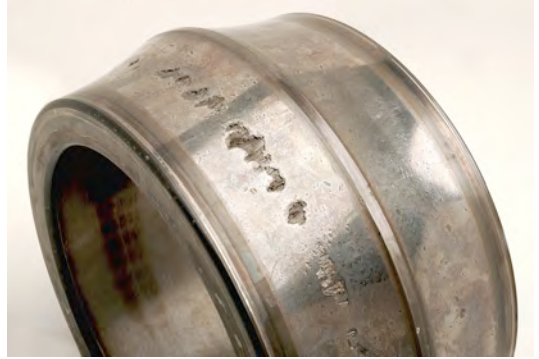
Above: Disassembled bearing with spallings.
